INFRARED ENERGY AUDIT

Any city, Ma. 01844

Date:11/29/07

INFRARED IMAGING REPORT

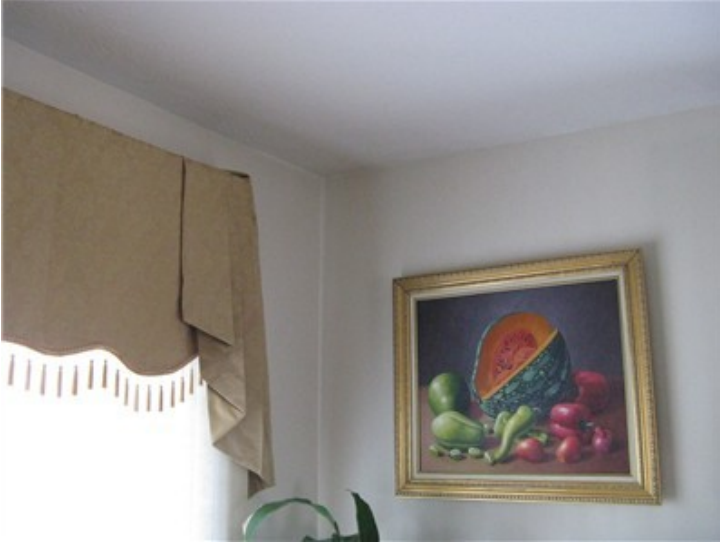
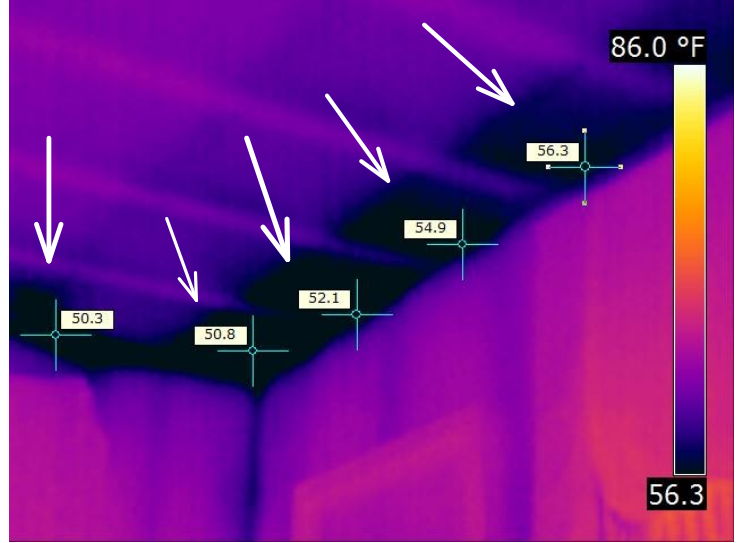
Location Floor: 1st Floor
 Room: Dining room
 Location Direction: Facing right side of house
 IR Camera Used: B-2 ThermaCam E-series

Note the excessive cold air infiltrating at the dark shaded areas. This shading is indicative of inadequate insulation inside the ceiling cavity. I recommend an insulation contractor evaluate and estimate costs of installing insulation into this concealed area.

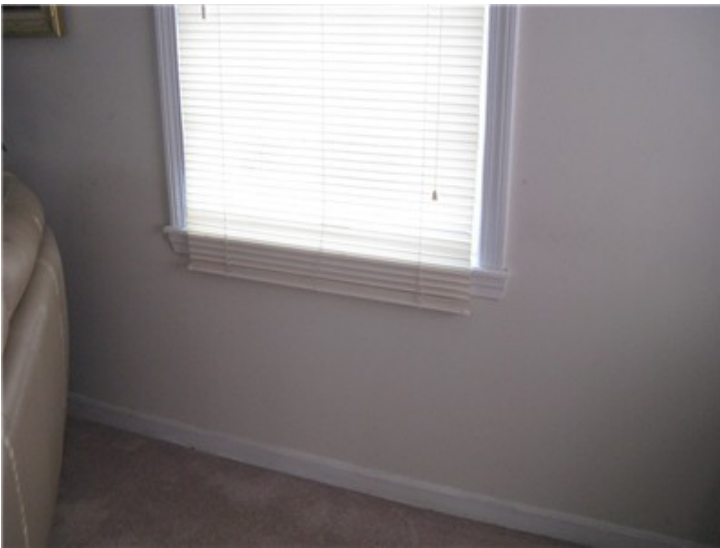
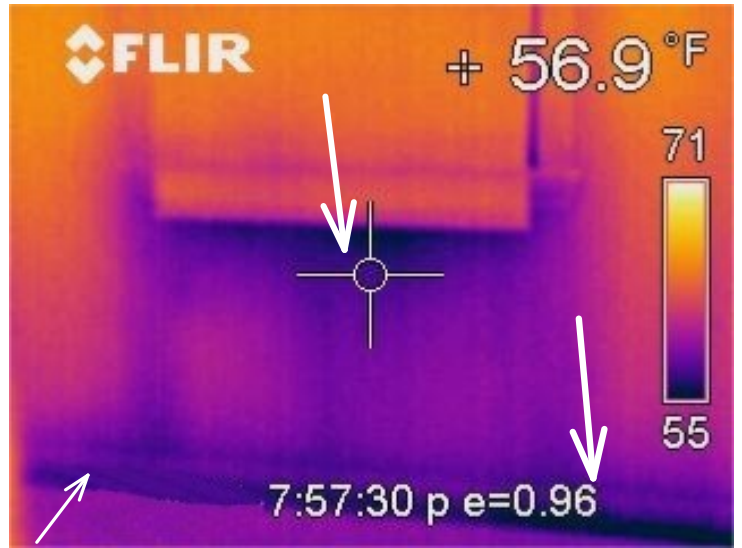
Location Floor: 1st Floor
 Room: Family room
 Location Direction: Facing right side of house
 IR Camera Used: B-2 ThermaCam E-series

Note the excessive cold air infiltrating at dark shaded areas below the window. Insufficient or settled insulation installed inside the wall cavities of this area. I recommend an insulation contractor evaluate and estimate costs of installing insulation in this area in order to improve efficiency.

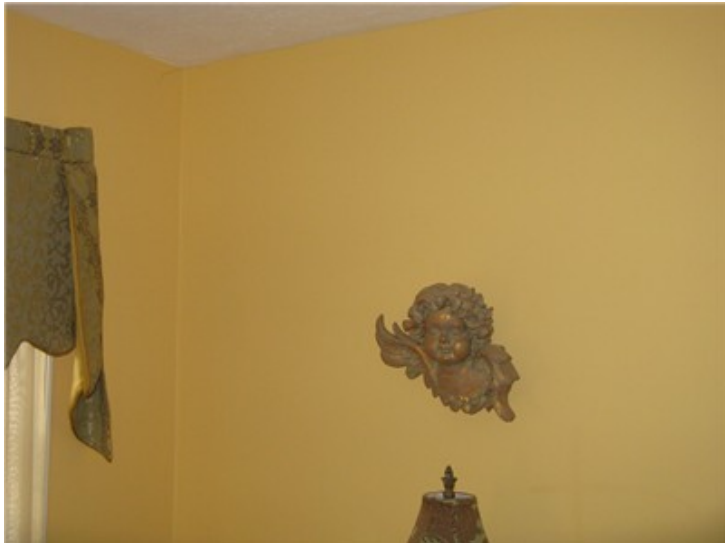
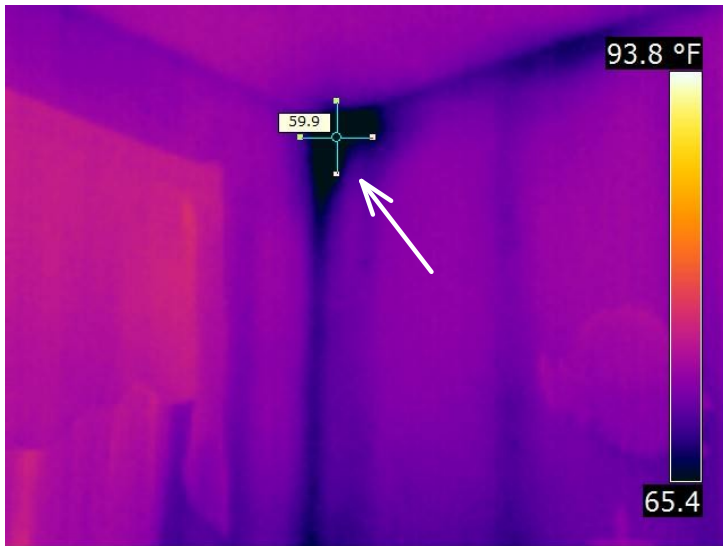
Location Floor: 2nd Floor
 Room: Master Bedroom
 Location Direction: Facing front of house
 IR Camera Used: B-2 ThermaCam E-series

Note the cold air (dark shade) infiltrating at the top left corner of this wall. This shading is indicative of inadequate or settled insulation inside the wall cavity. I recommend an insulation contractor evaluate and estimate costs of installing insulation in this particular area in order to improve efficiency.

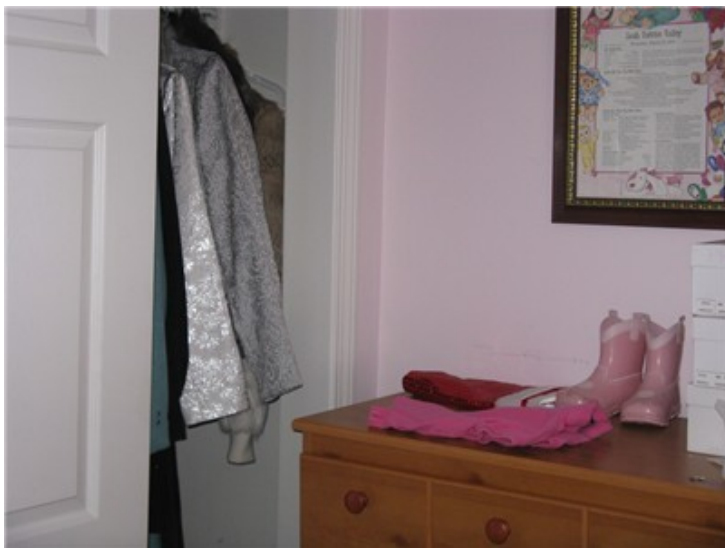
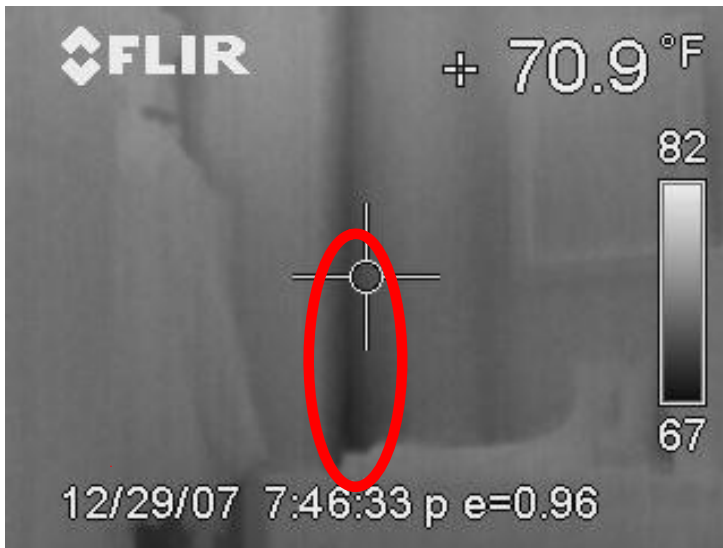
Location Floor: 2nd Floor
 Room: Bedroom at right side of house
 Location Direction: Facing rear of house
 IR Camera Used: B-2 ThermaCam E-series

The darker shade in the lower corner is indicative of air infiltration in this area. Corner transition areas are the most complex component of a building envelope to insulate. These areas are typically inefficient due to the Builders installing a four-stud corner, where the two exterior walls come together. This creates an air pocket behind the corner studs which leaves this corner with all wood and no insulation.

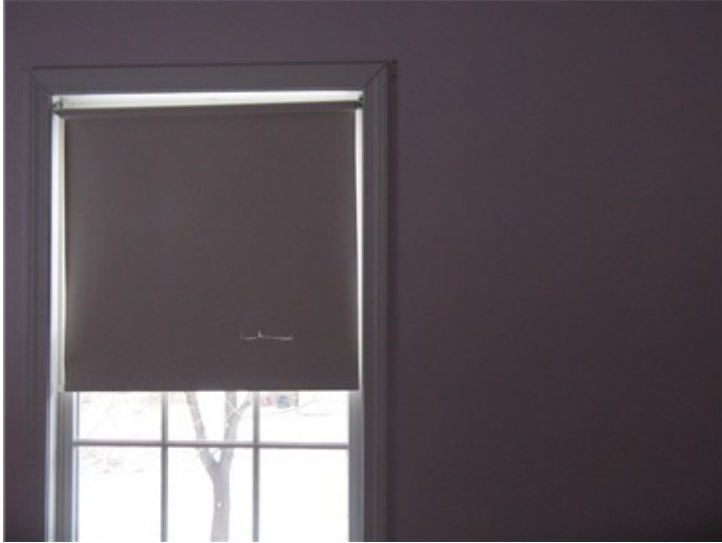
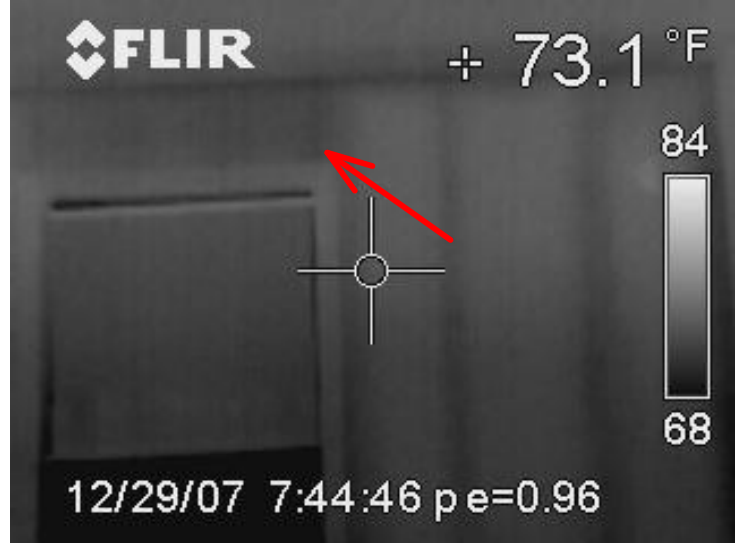
Location Floor: 2nd Floor
 Room: Bedroom at right side of house
 Location Direction: Facing right side of house
 IR Camera Used: B-2 ThermaCam E-series

Note the colder area (dark shade) on top of this window and throughout the wall. These areas are typically colder due to the installation of the header members and studs, which are conducting cold air from the exterior. Insulation cannot be installed at headers because there's no cavity. When insulation is installed in the wall cavities, it goes between the studs only. So the studs themselves conduct cold air from the exterior.

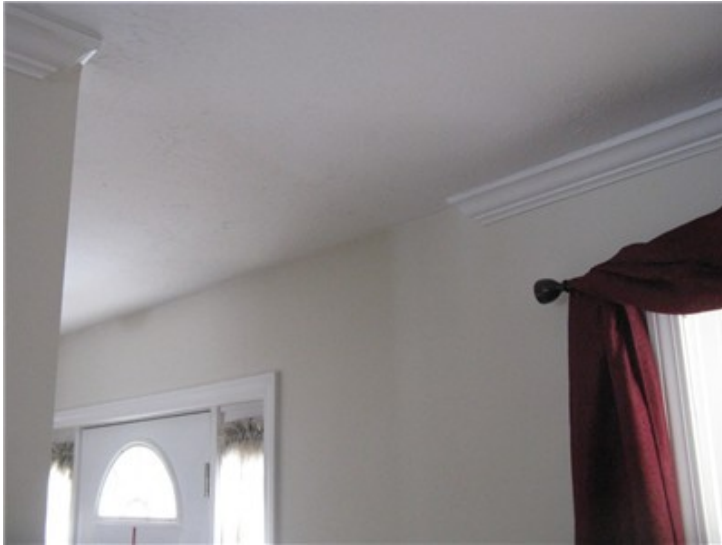
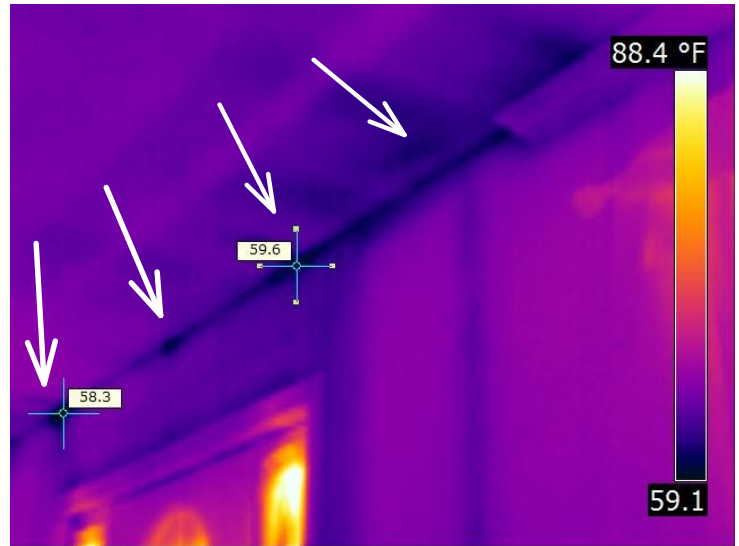
Location Floor: First Floor (1st)
 Room: Living room
 Location Direction: Facing front of house
 IR Camera Used: B-2 ThermaCam E-series

Note darker shaded areas where cold air is infiltrating. There is Insufficient insulation in this area. I recommend an insulation contractor evaluate and estimate costs of installing insulation in this area. Spray foam may be considered.

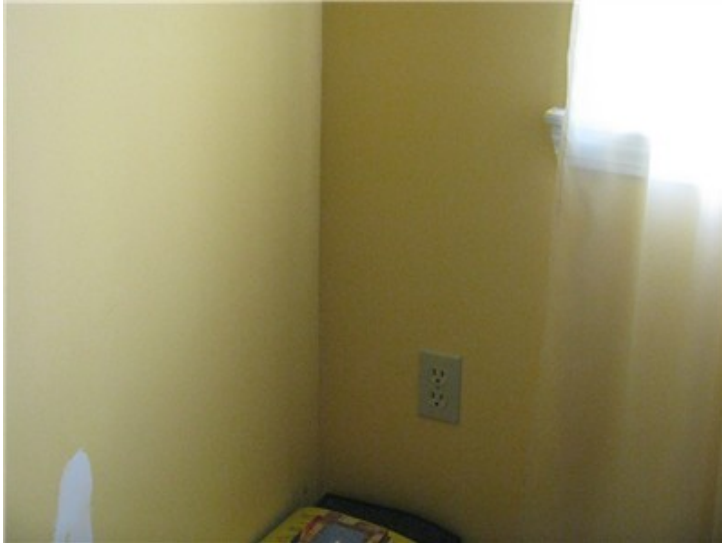
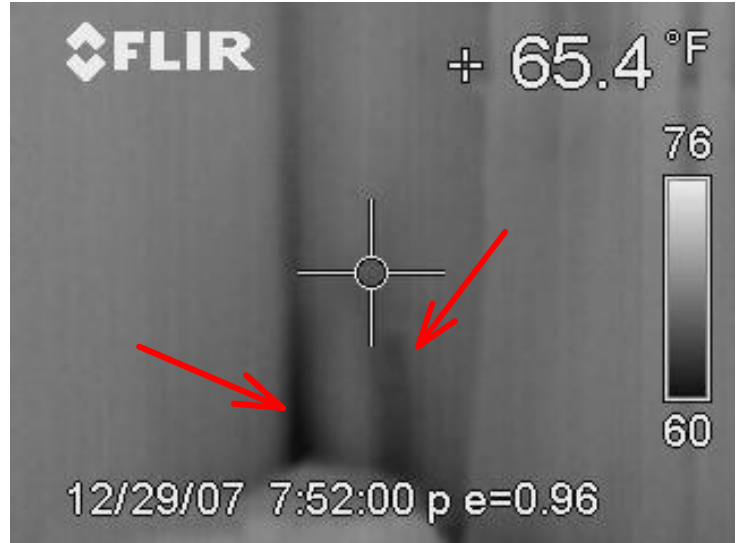
Location Floor: 2nd Floor
 Room: Master Bedroom
 Location Direction: Facing front of house
 IR Camera Used: B-2 ThermaCam E-series

Note the cold air (dark shaded area) infiltrating at the lower corner of this room and outlet. This shading is indicative of inadequate insulation. May consider upgrading this area with a foam insulation.

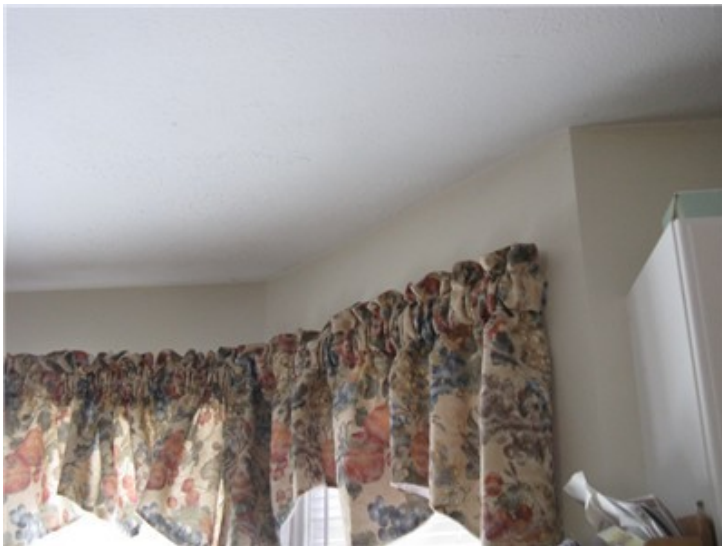
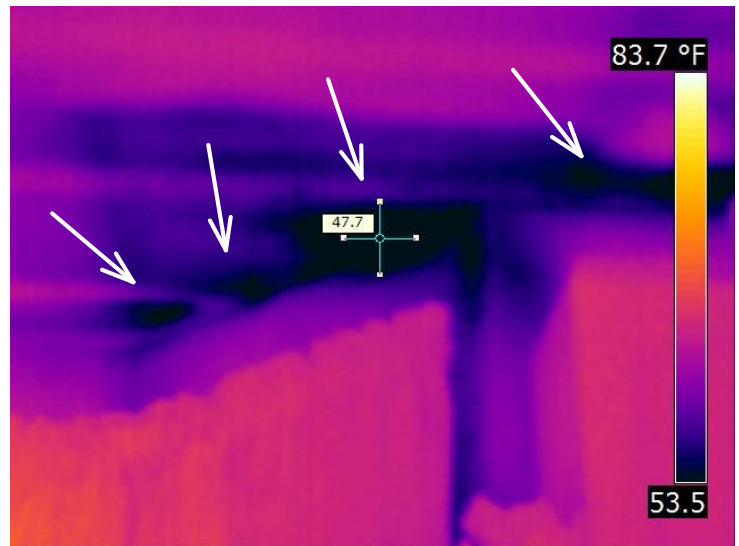
Location Floor: 1st Floor
 Room: Kitchen
 Location Direction: Facing rear of house
 IR Camera Used: B-2 ThermaCam E-series

Note the cold air infiltrating at the dark shaded areas. Insufficient insulation installed in this area. I recommend an insulation contractor evaluate and estimate costs of installing insulation in this particular area.

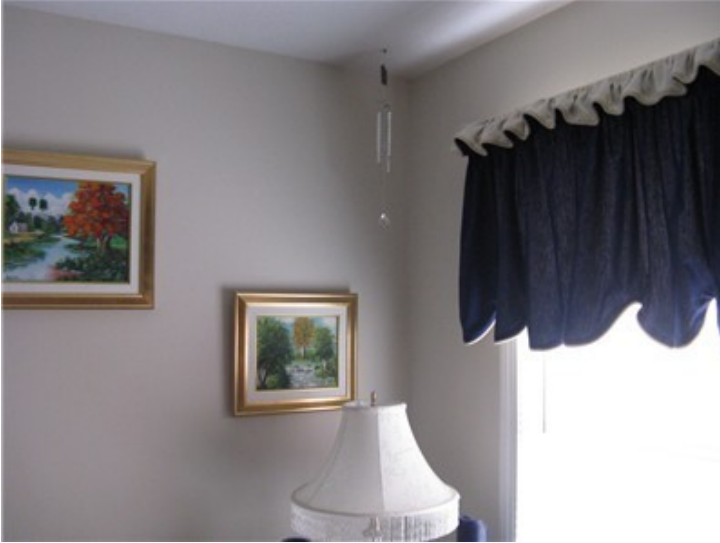
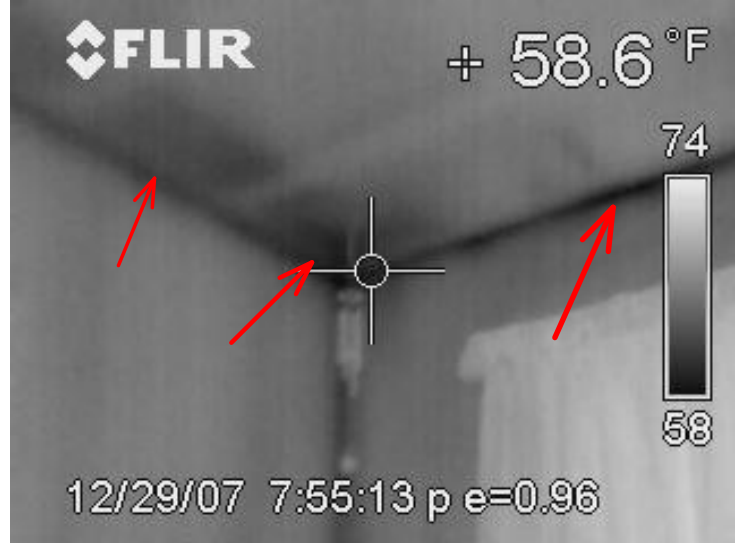
Location Floor: 1st Floor
 Room: Family room
 Location Direction: Facing front of house
 IR Camera Used: B-2 ThermaCam E-series

Note the cold air (dark shade) infiltrating at the top corner of this room. This shading is indicative of inadequate insulation. I recommend an insulation contractor evaluate and estimate costs of installing insulation in this particular area.

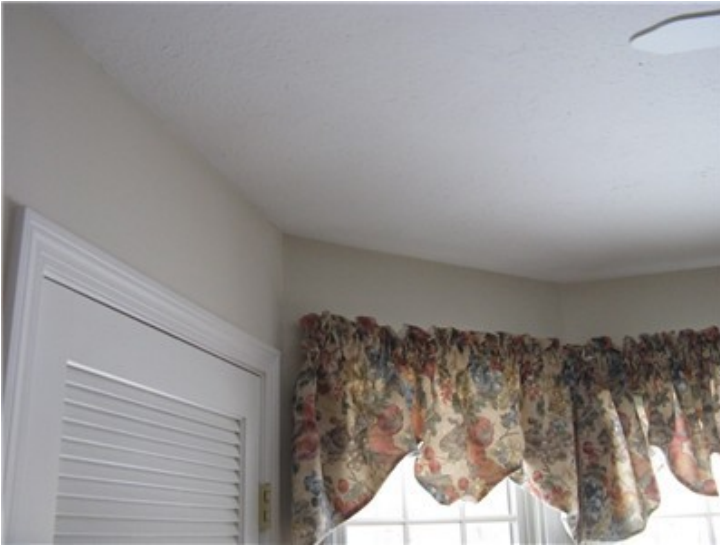
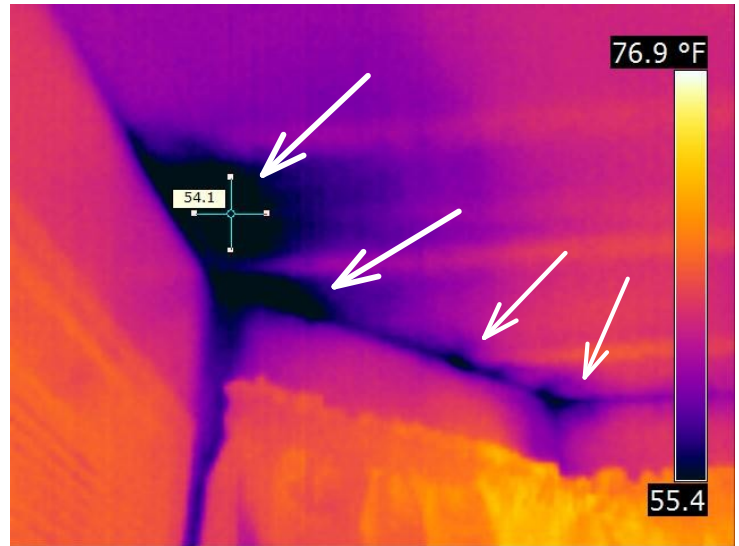
Location Floor: 1st Floor
 Room: Kitchen
 Location Direction: Facing rear of house
 IR Camera Used: B-2 ThermaCam E-series

Note the cold air infiltrating at dark shaded areas. Insufficient insulation installed in this area. I recommend an insulation contractor evaluate and estimate costs of installing insulation in this particular area.

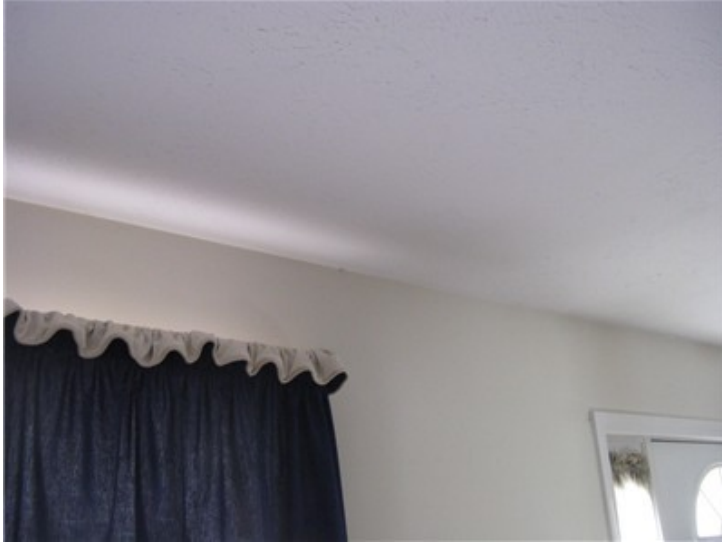
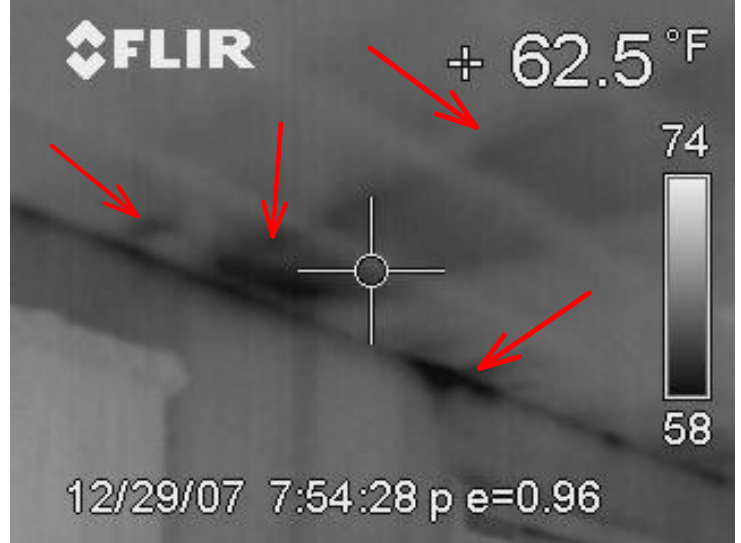
Location Floor: 1st Floor
Room: Family room
Location Direction: Facing front of house
IR Camera Used: B-2 ThermaCam E-series

Note the cold air infiltrating at dark shaded areas. This shading is indicative of inadequate insulation. Consider upgrading this area with additional insulation, in order to improve efficiency. I recommend an insulation contractor evaluate and estimate costs of installing insulation in this area.
